Monitoring Data Record

Project Title: R-2206B (NC 16 Bypass) COE Action ID: 200431320
 Stream Name: UT to Forney Creek (Site 10B) WQC Number: 3476
 City, County and other Location Information: Lincoln County, NC 16 Bypass
 (Sta. 159+00 LT.-L-)

Year 1 Summer – September 2008

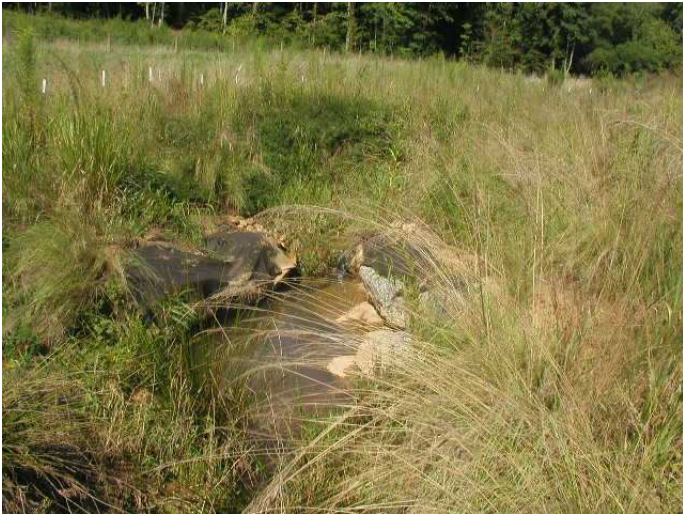
Photo Point #5 (Upstream)

UT to Forney Creek has some localized bank erosion behind the left arm of a crossvane at Photo Point #5 (Upstream). The crossvane at Photo Point #5 (Downstream) has water piping under the header rock. The right arm of this crossvane has dropped off into the channel, however, only a portion of the right arm actually fell into the channel. The remaining portion of the channel is in stable condition for Year 1 Summer evaluation. A bankfull event has occurred since the last monitoring evaluation. Repair work did take place at the stream relocation in October 2008 to repair the problem areas.

Date 9/3/08	Sta. 159+50 PP#5 (Upstream)	Sta. 159+40 PP#5 (Downstream)	Station Number	Station Number	Station Number
Structure Type	Crossvane	Crossvane			
Is water piping through or around structure?		Water is piping under the crossvane			
Head cut or down cut present?		Headcut			
Bank or scour erosion present?	Minor erosion behind left arm of crossvane	Minor erosion on the right end of the cross vane			
Other problems noted?		A portion of the right arm of the crossvane has dropped off into the channel
